# Fergana Eco City Regional Hospital – Uzbekistan

## Appendices – Volume 4

### Vision Invest

## Appendix A   Project Layouts

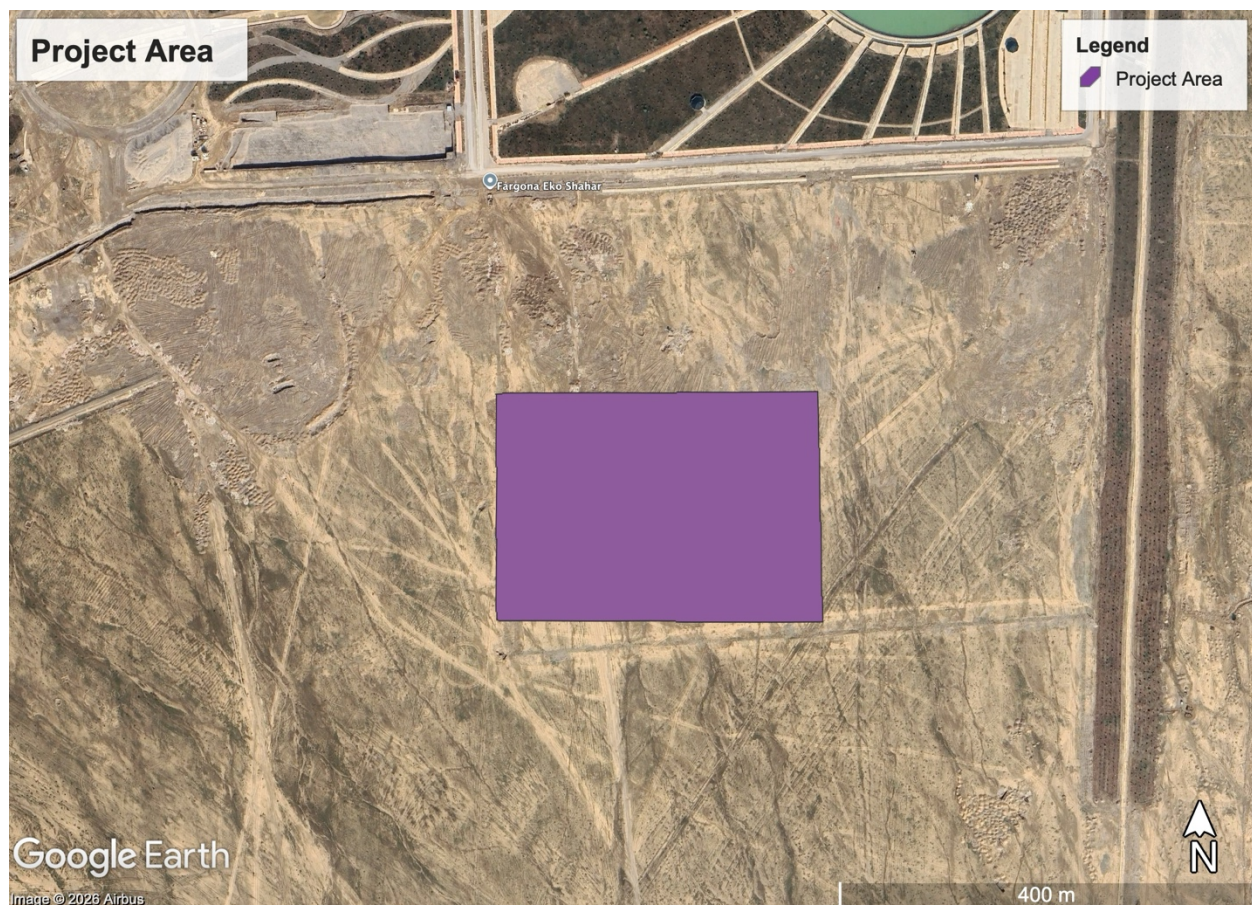
**Figure 1: Project Site Location**

The following features are located around the project area:

- Fergana Eco-City — 200 m from the northern boundary;
- Fergana International Airport — runway is 1 km from the eastern boundary;
- Agricultural lands — 2 km from the western boundary; and
- Vacant lands (possibly previously used as pastures) — to the south.

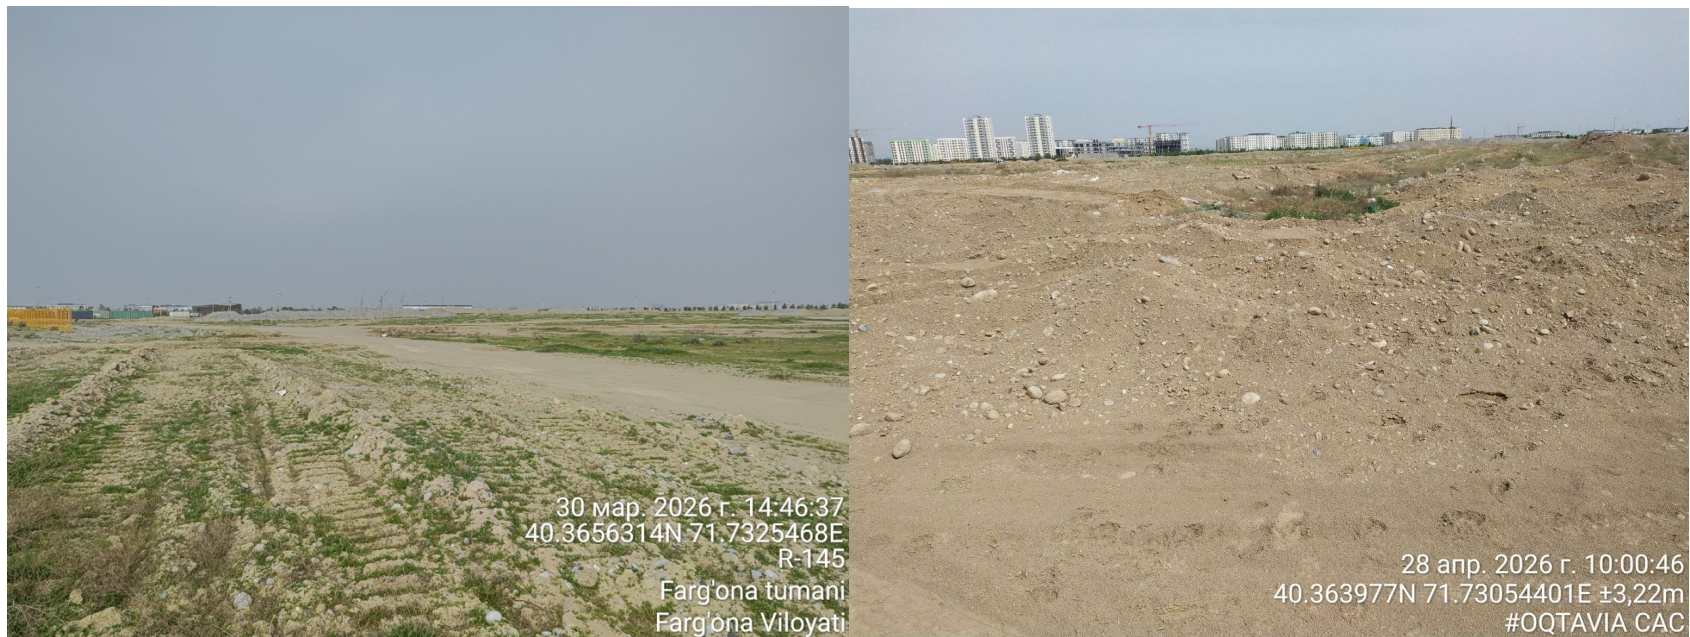
**Figure 2: Construction Near the Project Site**

Construction activities have not yet commenced within the project site; however, the area is actively used for the movement of heavy machinery, as well as for the storage of construction materials and excavated soil from the neighboring developments (Figure 2).

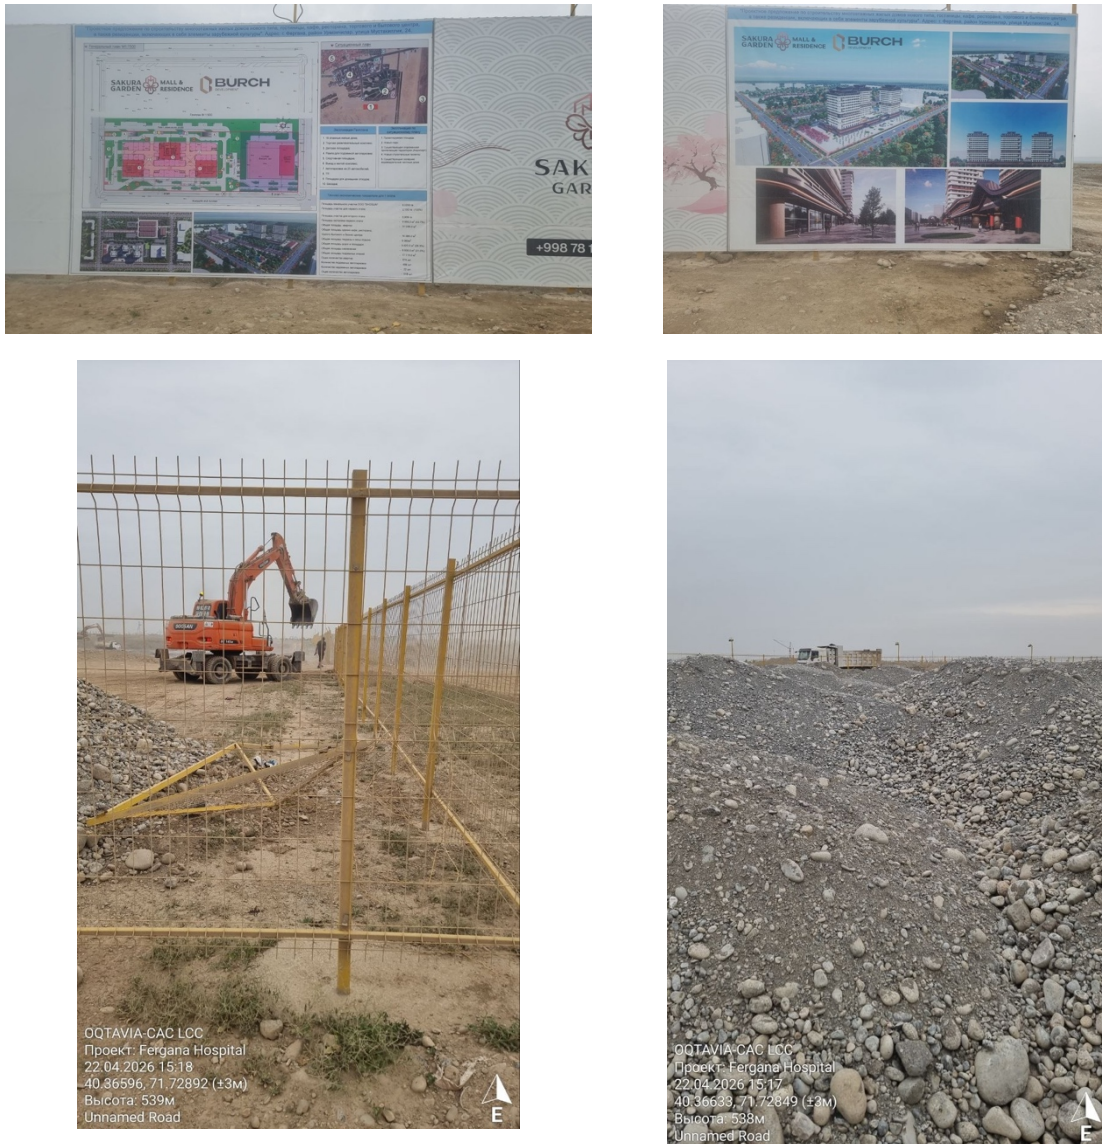
**Figure 3: Construction of the “Sakura Garden Mall & Residence” residential complex, Burch Development**

Additionally, construction work for the “Sakura Garden Mall & Residence” residential complex by Burch Development has begun north of the proposed project site. These works include excavating soil for the foundation of 16-story residential buildings and storing the excavated soil (Figure 3).

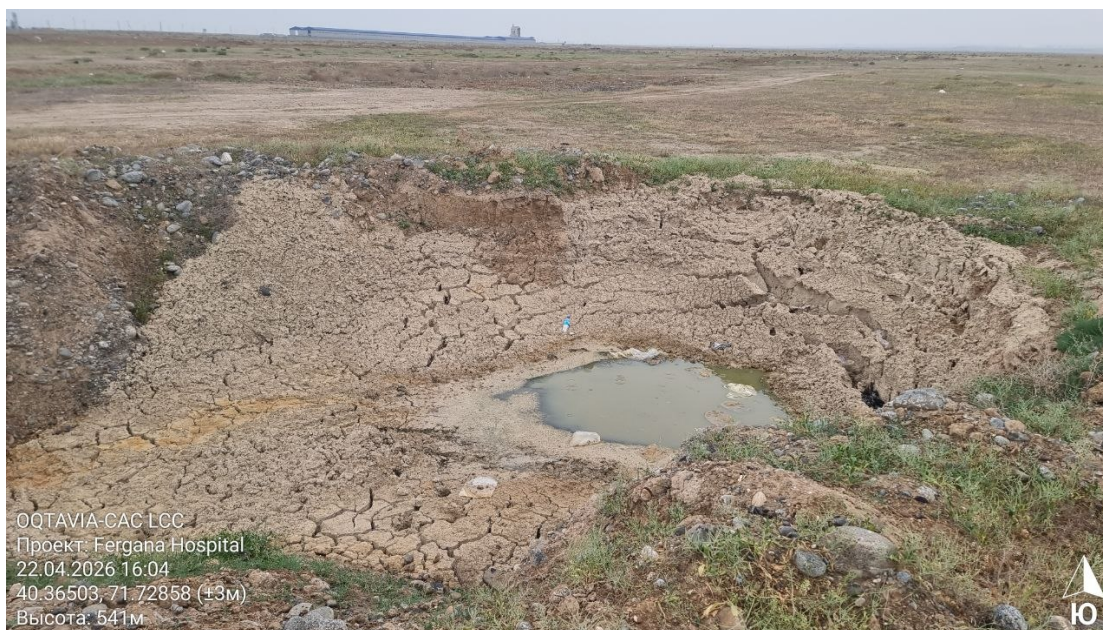
The main unpleasant odor at the site of the planned works came from what is presumed to be an accumulation of sewage – presumably from a cesspit – along with the smell of stagnant water and fecal matter.

The odour emanating from the discharged sewage (the smell of stagnant water and faecal matter) is located in the low-lying area adjacent to the project site.

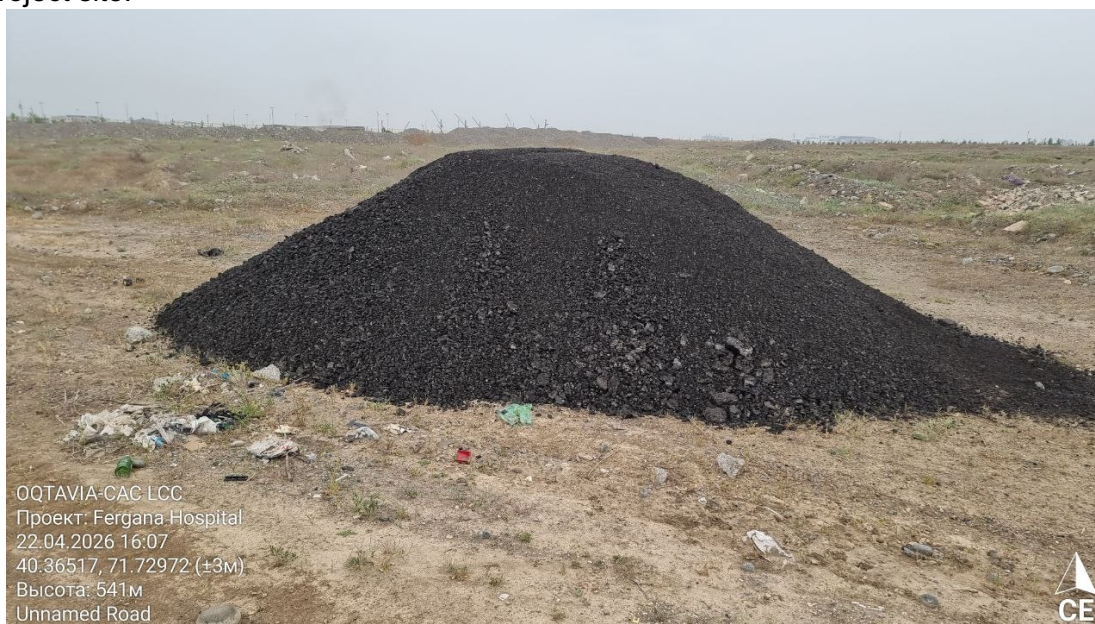
The second source of the odour was a pile (consisting of asphalt chips and chunks of asphalt) of old asphalt that had been removed from somewhere unknown and brought to the project site. The typical smell of bitumen emanating from the removed asphalt surfacing that had been brought to the project site.

The source of the bitumen odour emanating from the waste asphalt removed from the project site.

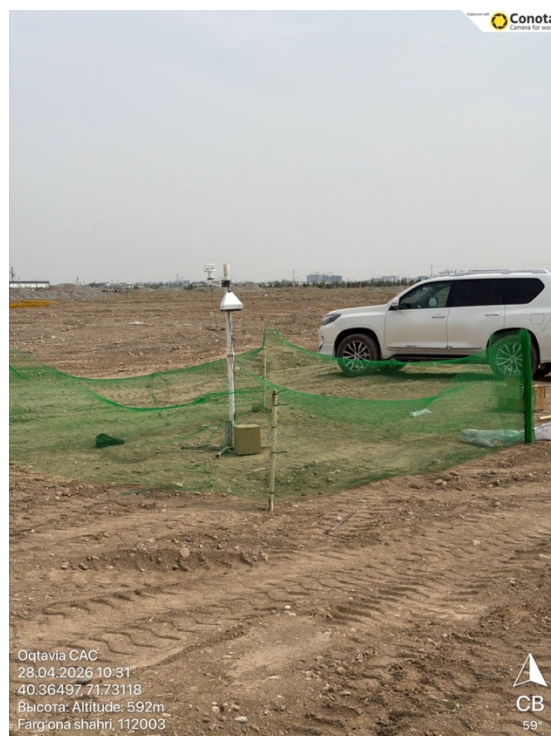
**Figure 5: Installation of AQMesh pod**

The pod was installed by the project team at 10:30 AM on 28 April, 2026 at the coordinates 40.36497, 71.73118 (Figure 4 and Figure 5). The selected location lies along the northern boundary of the project footprint, which directly borders with another project area.

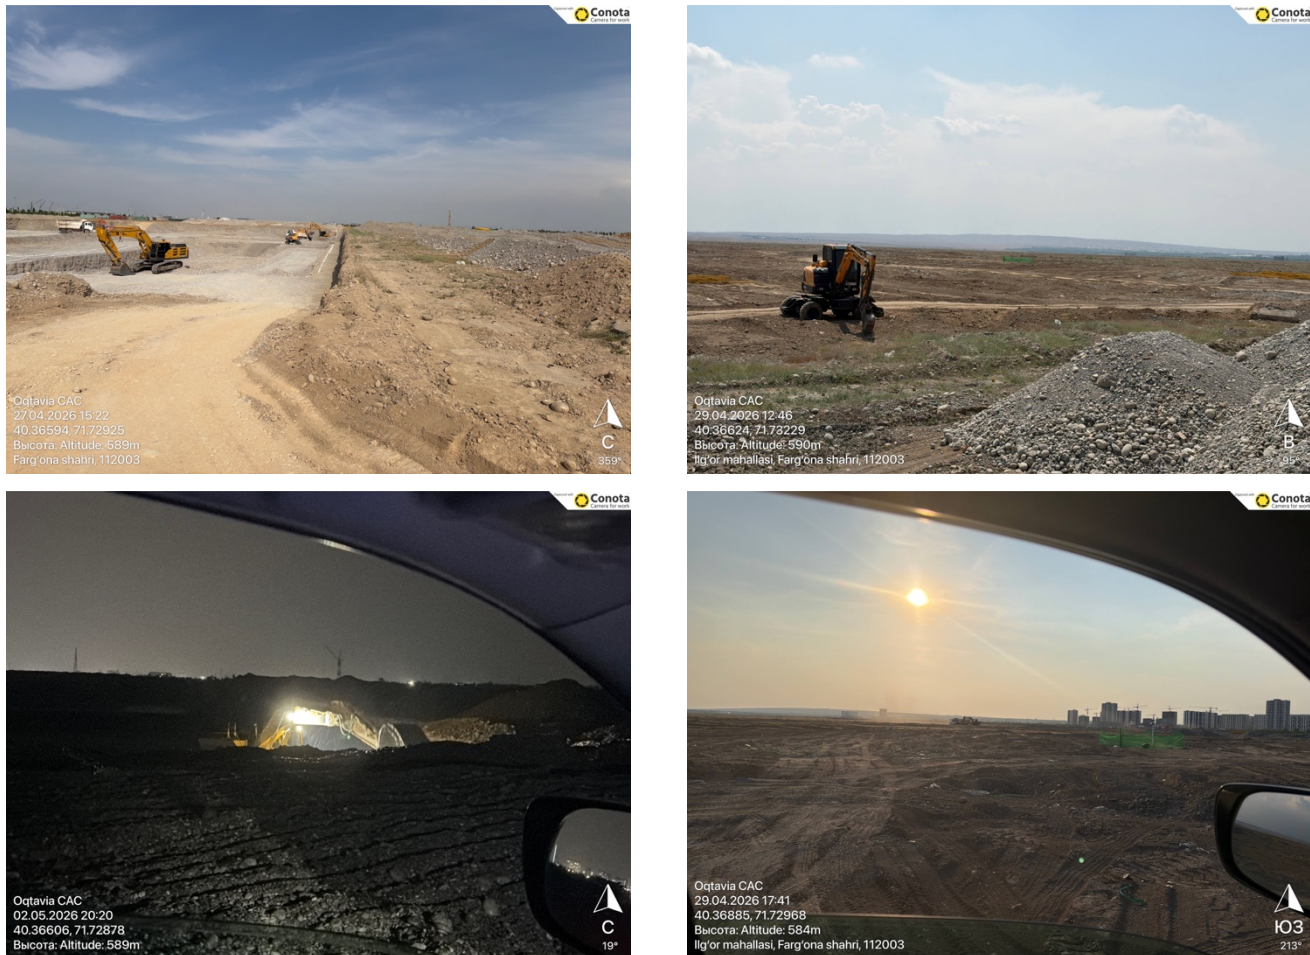
**Figure 6: Nearby activities during surveys**

At the time of the survey, active work was being carried out in a nearby quarry to prepare an excavation pit for future construction (Figure 6). Operations at this site reportedly occur from 07:00 to 24:00. Due to the proximity of construction activities, particularly the movement of heavy vehicles near the monitoring location, elevated particulate matter (PM) concentrations recorded by the AQMesh pod may be influenced by these external sources.

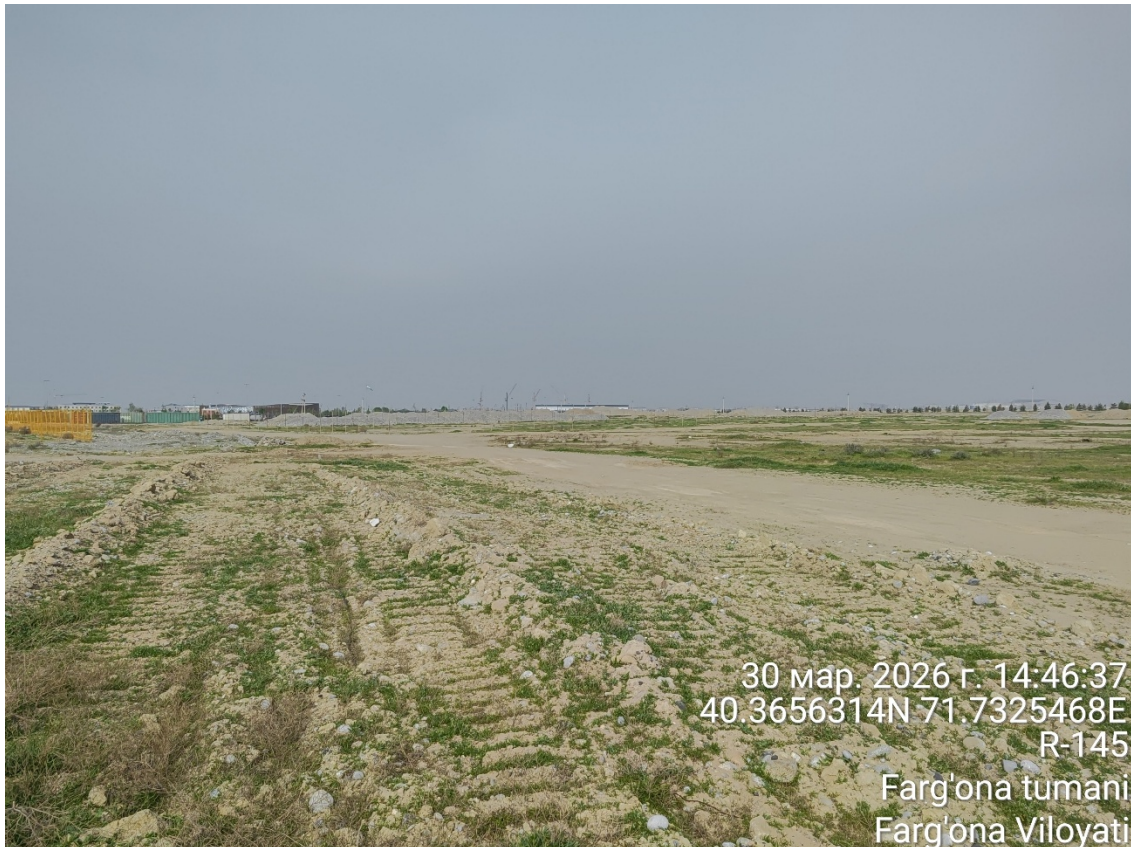
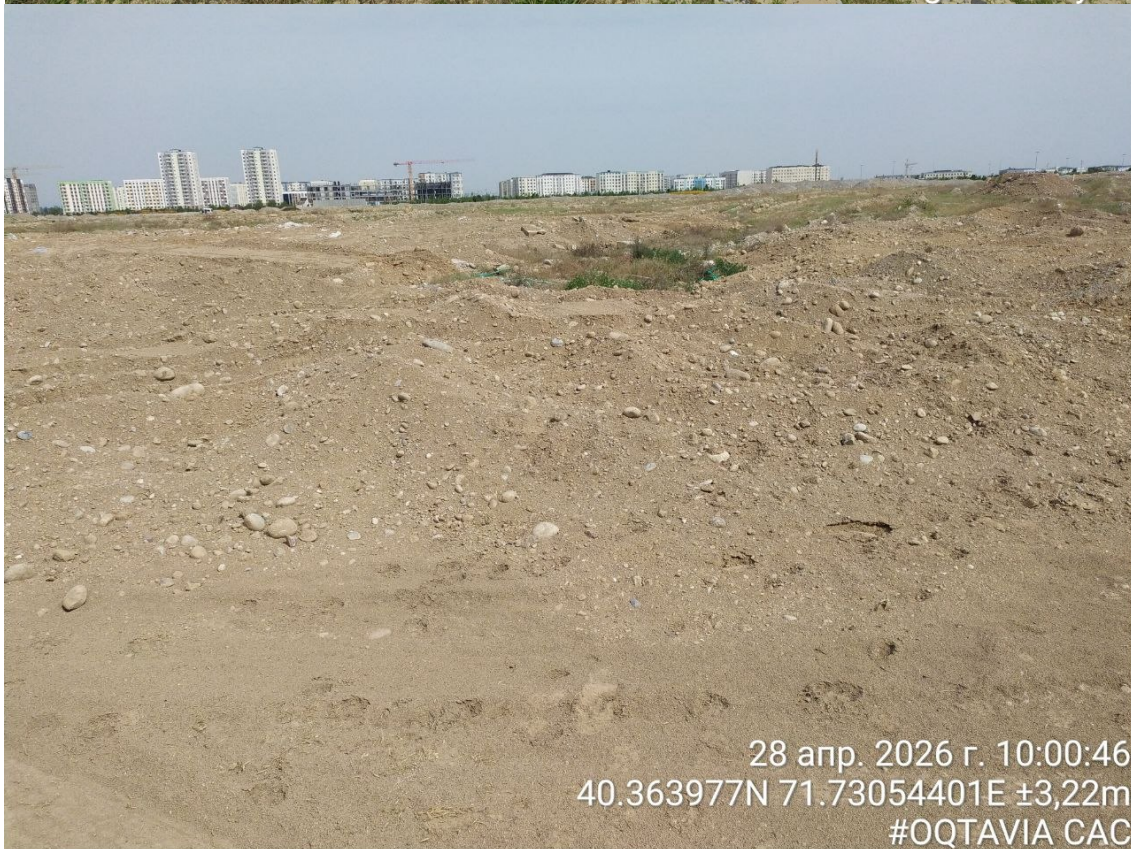
**Figure 2: Construction Near the Project Site**

Construction activities have not yet commenced within the project site; however, the area is actively used for the movement of heavy machinery, as well as for the storage of construction materials and excavated soil from the neighboring developments (Figure 2).

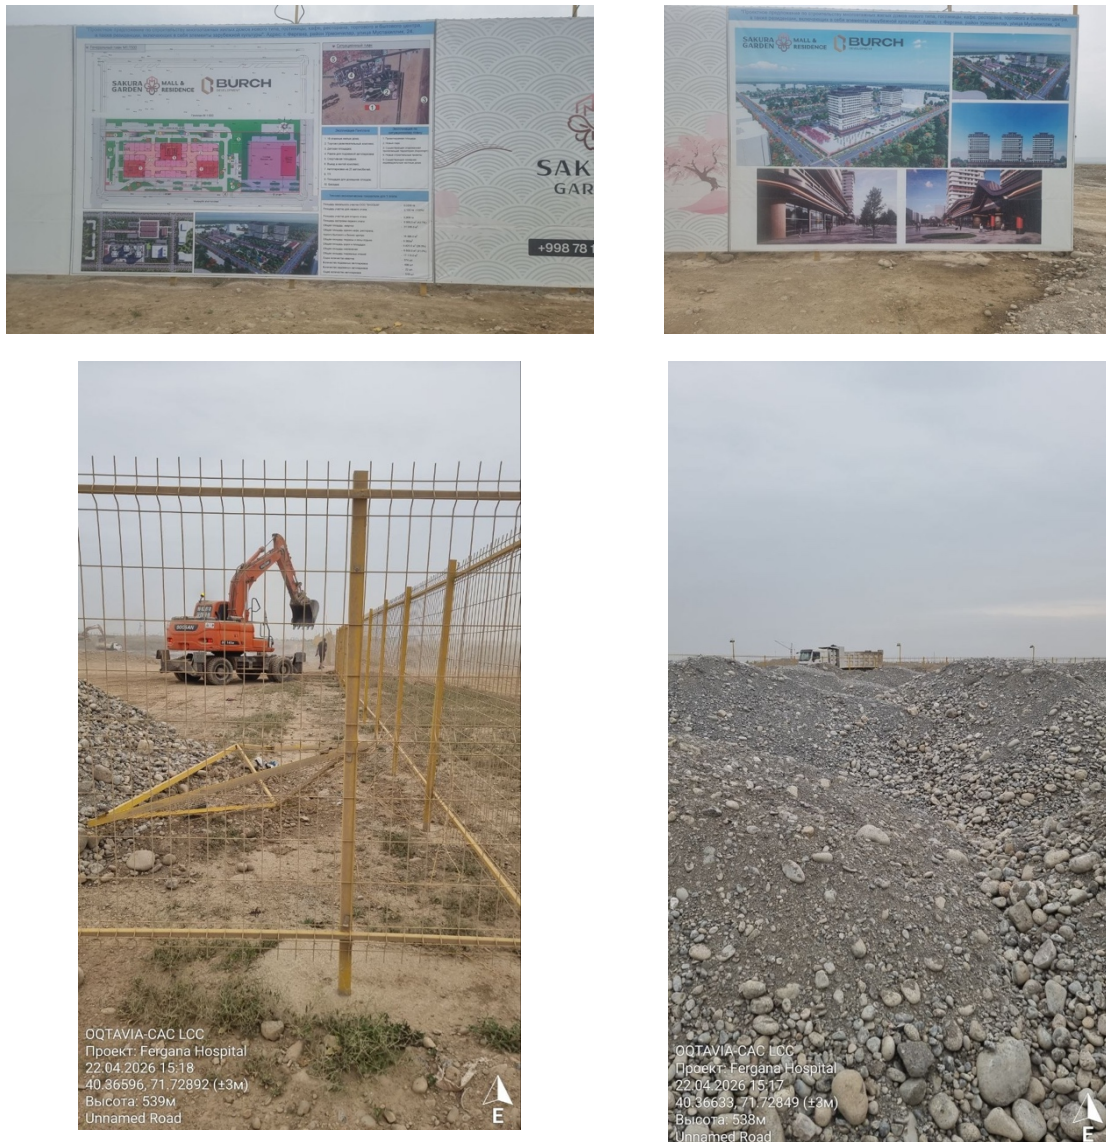
**Figure 3: Construction of the “Sakura Garden Mall & Residence” residential complex, Burch Development**

Additionally, construction work for the “Sakura Garden Mall & Residence” residential complex by Burch Development has begun north of the proposed project site. These works include

excavating soil for the foundation of 16-story residential buildings and storing the excavated soil (Figure 3).

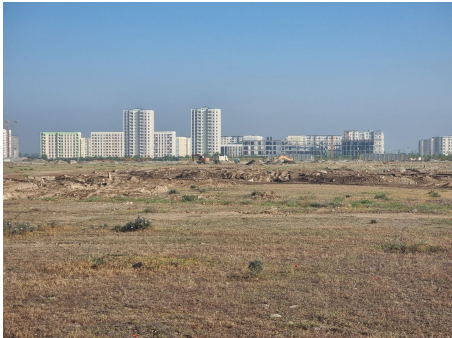
1. Noise from construction machinery used at nearby building sites whilst carrying out earthworks and transport operations to excavate soil for building foundations, the removal of soil by specialized vehicles, and noise from bucket excavators during earthworks.

| Bucket excavator works | Bulldozer works | Work being carried out on the adjacent site using specialist machinery; photo taken from the project site. |

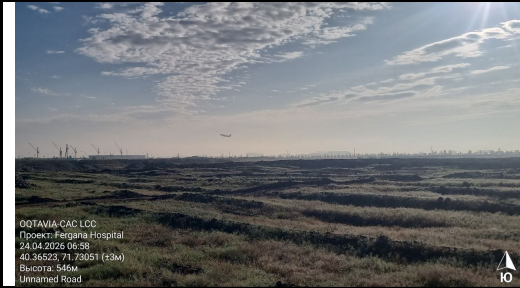
- The second source of noise in the project area is the operation of Fergana Airport. The airport regularly handles flights several times a day. Temporary noise from airliners is observed during take-offs and landings.

| Flights departing from Fergana Airport: morning and evening flights. | |

The airport handles up to 7 flights a day, including both domestic and international flights.

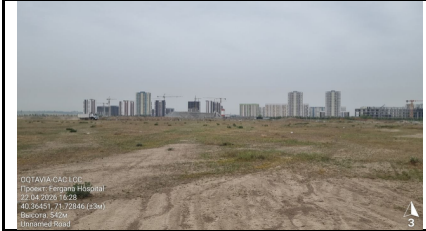
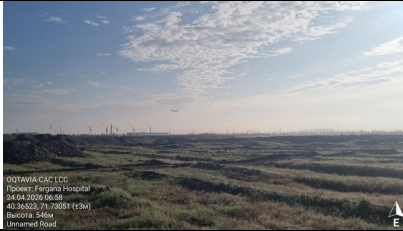
- Everyday noise in the projection area is mainly caused by construction work at nearby building sites – the sounds of loading and unloading building materials, the clanging of metal, the creaking of construction cranes, specialized vehicles and other mechanical noises; at times, noise from the airport's cargo terminal can be heard, as well as recorded calls of birds of prey (falcon calls) used to scare birds away to ensure the safe landing of flights.

| Noise transmitted from construction cranes whilst construction work is being carried out. | Noise coming from the airport's cargo terminal and recorded sounds of birds of prey from the direction of the airport. |

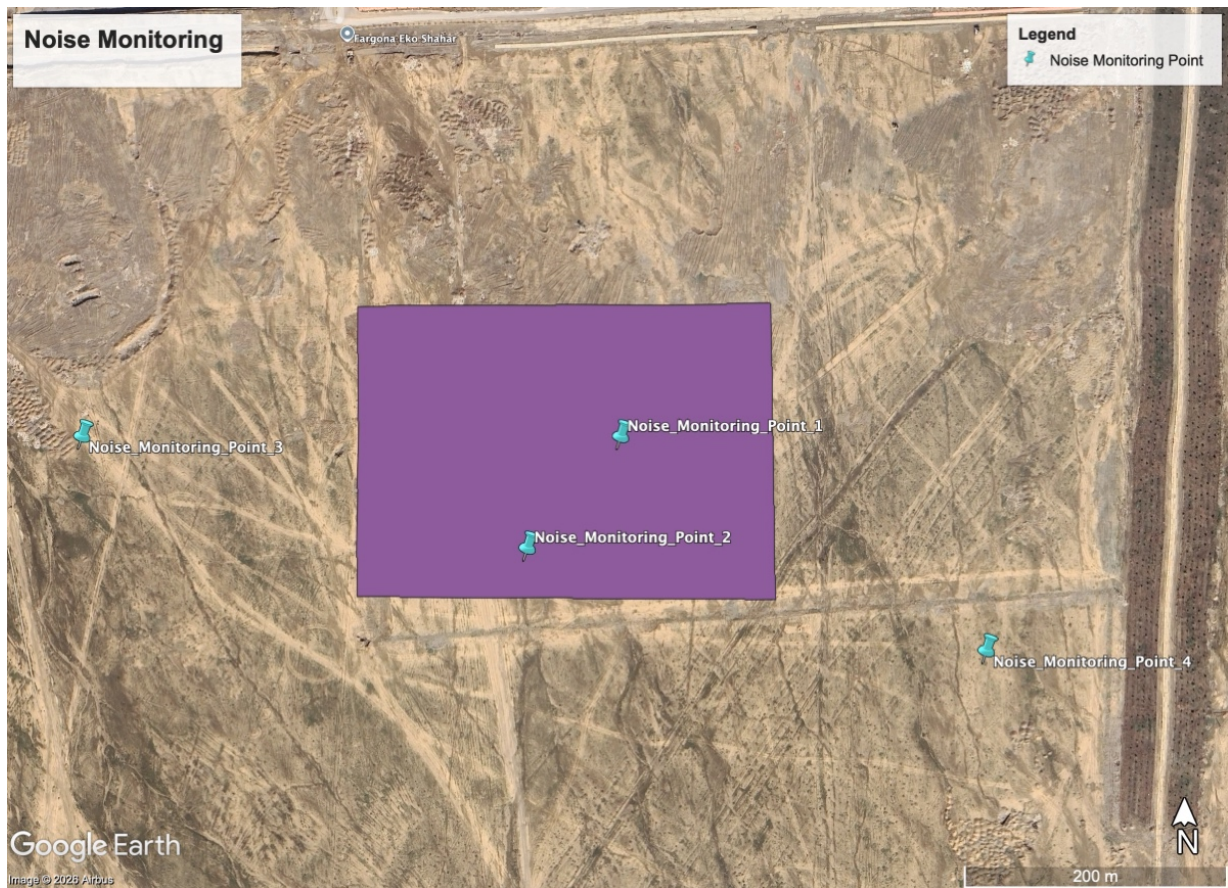
**Figure 4: Location of Noise Monitoring Points**

| Point No. | Coordinates | Notes |
|---|---|---|
| Noise Monitoring Point 4 | 40°21'48.63"N, 71°44'4.04"E | Out of the project area, located in the direction of the nearby Fergana International Airport |

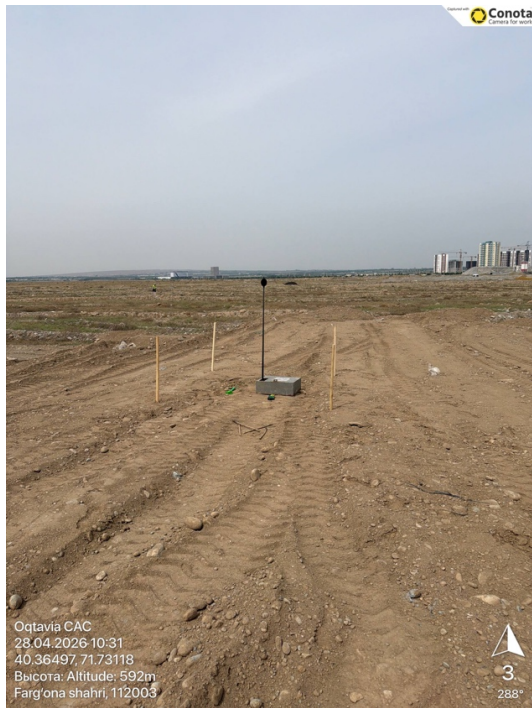
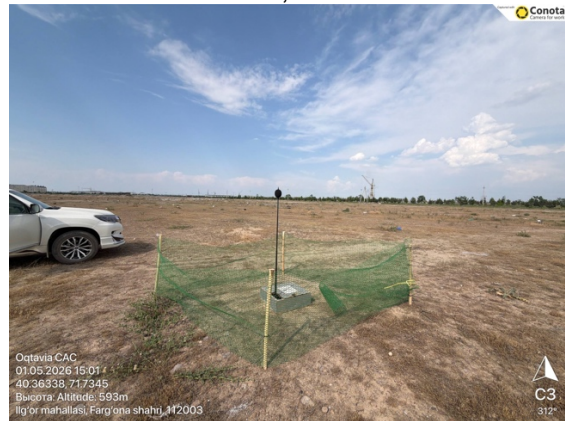
**Figure 5: Photos of Noise Monitoring Equipment at Each Location**

Four monitoring points were chosen – two within the project area and two outside the project area to represent background noise levels (Table 1 and Figure 4). Photos of the equipment at the monitoring locations are presented in Figure 5.

**Noise Monitoring Point 1**  
40°21'53.95"N, 71°43'52.16"E

**Noise Monitoring Point 4**  
40°21'48.63"N, 71°44'4.04"E

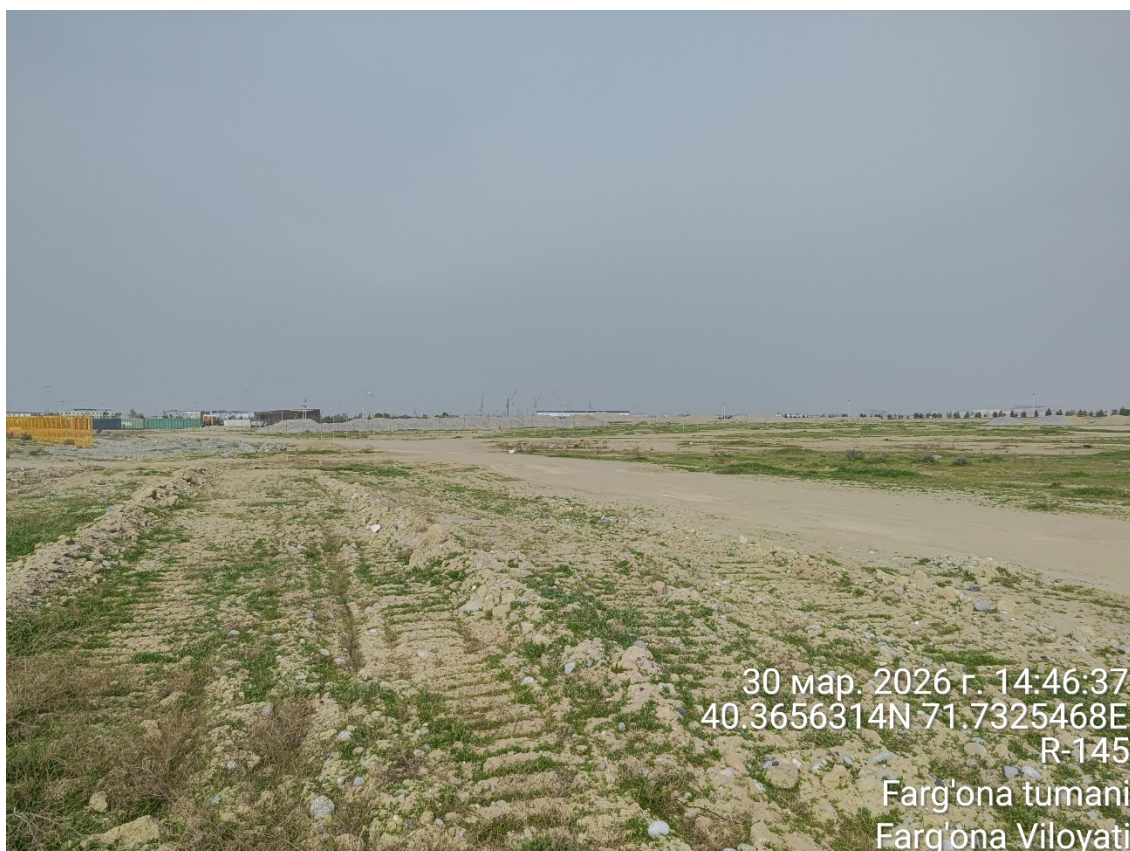
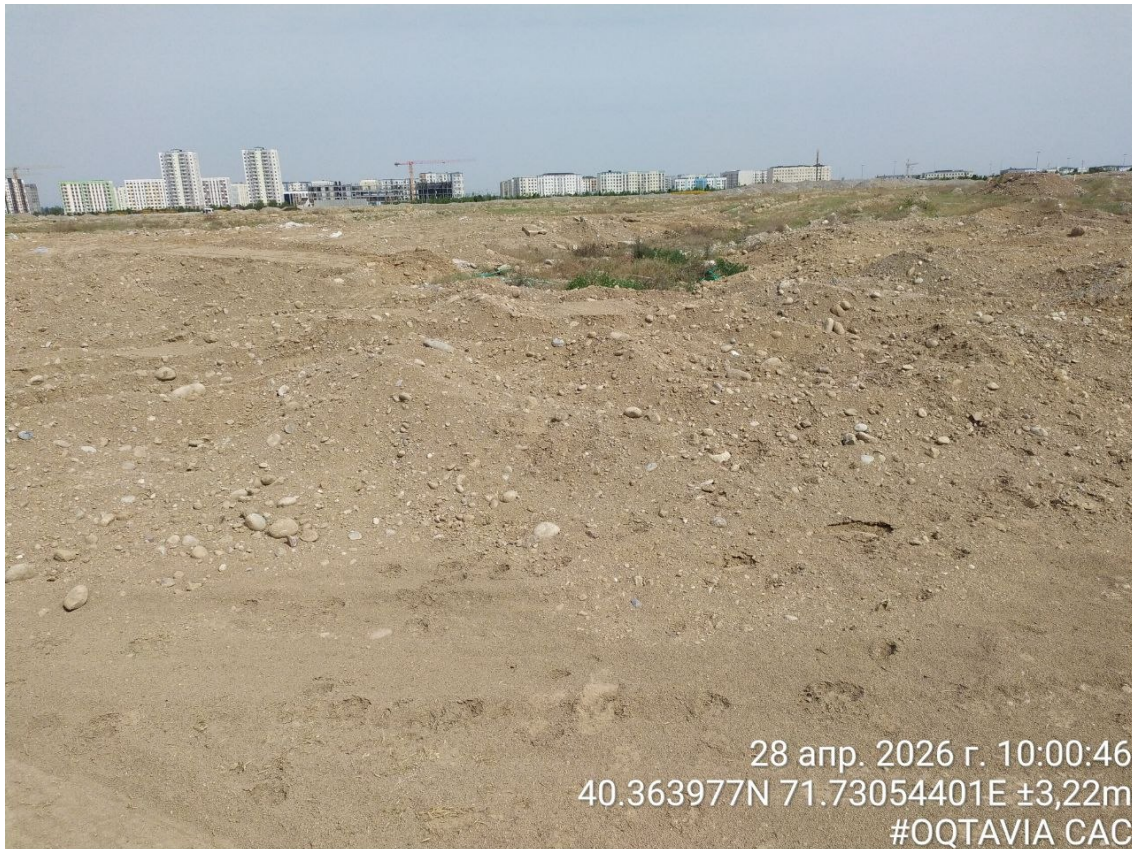
**Figure 2: Construction Near the Project Site**

The area shows widespread signs of human impact (Figure 2). Approximately half of the Project site (central and northern part) represents a land completely disturbed by excavation works and devoid of vegetation. In the eastern, southeastern and southwestern part of the Project area, there is sparse and patchy herbaceous vegetation strongly disturbed by movement of heavy vehicles; a dense network of their traces is clearly visible both on satellite images and in the field.

At present, active construction works are being carried out on the plots adjacent to the project area. Whilst construction activities have not yet commenced within the project site, analysis of satellite imagery and field observations both showed that the area is actively used for the movement of heavy machinery, as well as for the storage of construction materials and excavated soil from the neighboring developments.

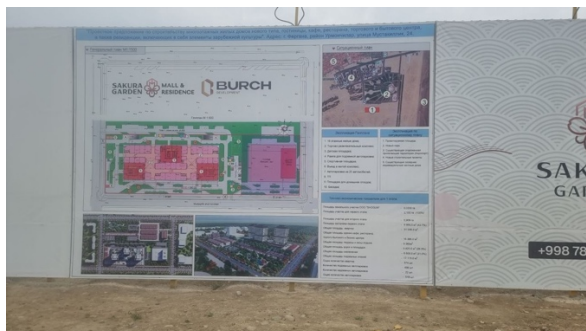
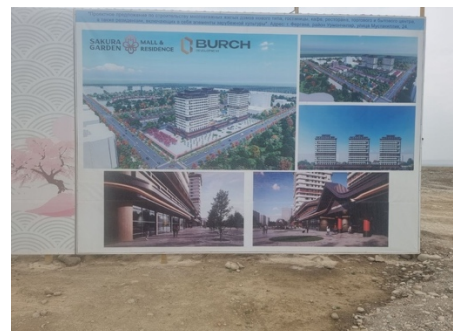
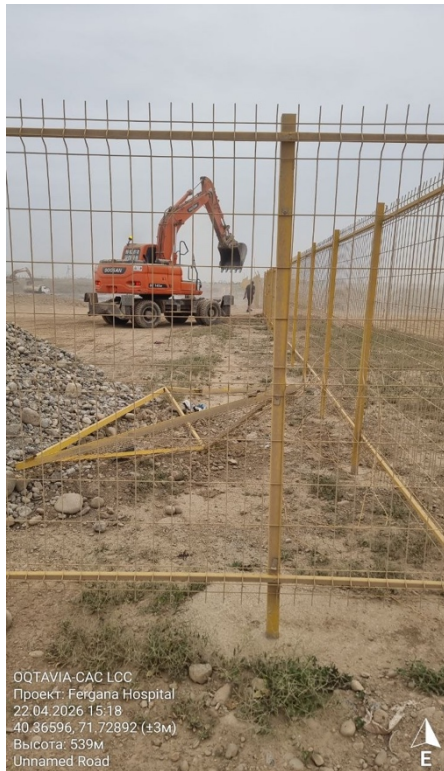
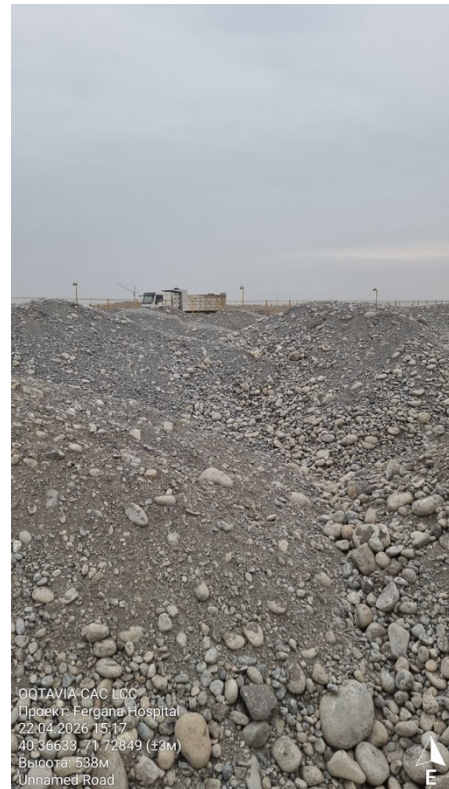
**Figure 3: Construction of the “Sakura Garden Mall & Residence” residential complex, Burch Development**

Additionally, construction work for the “Sakura Garden Mall & Residence” residential complex by Burch Development has begun north of the proposed project site. These works include excavating soil for the foundation of 16-story residential buildings and storing the excavated soil (Figure 3).

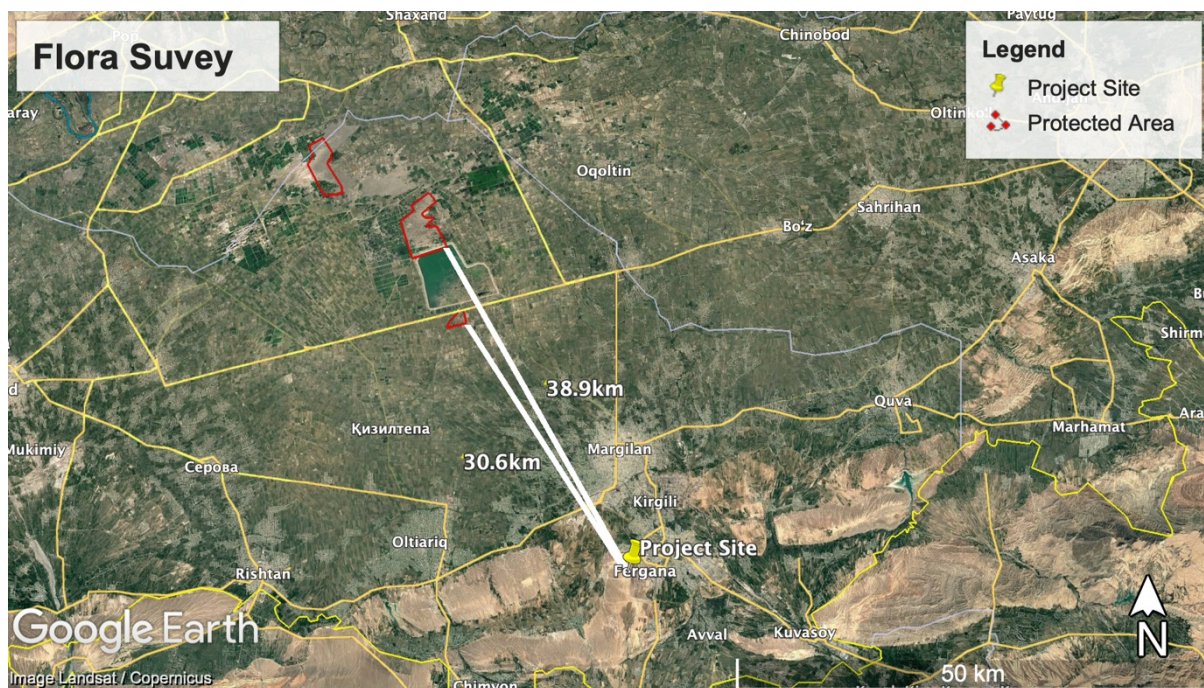
**Figure 4: Protected Areas Near the Project Site**

These protected areas are designated as natural monuments, classified as IUCN Category IV. The distance from the project site to the nearest protected area is approximately 30.6km northwest (Figure 4).

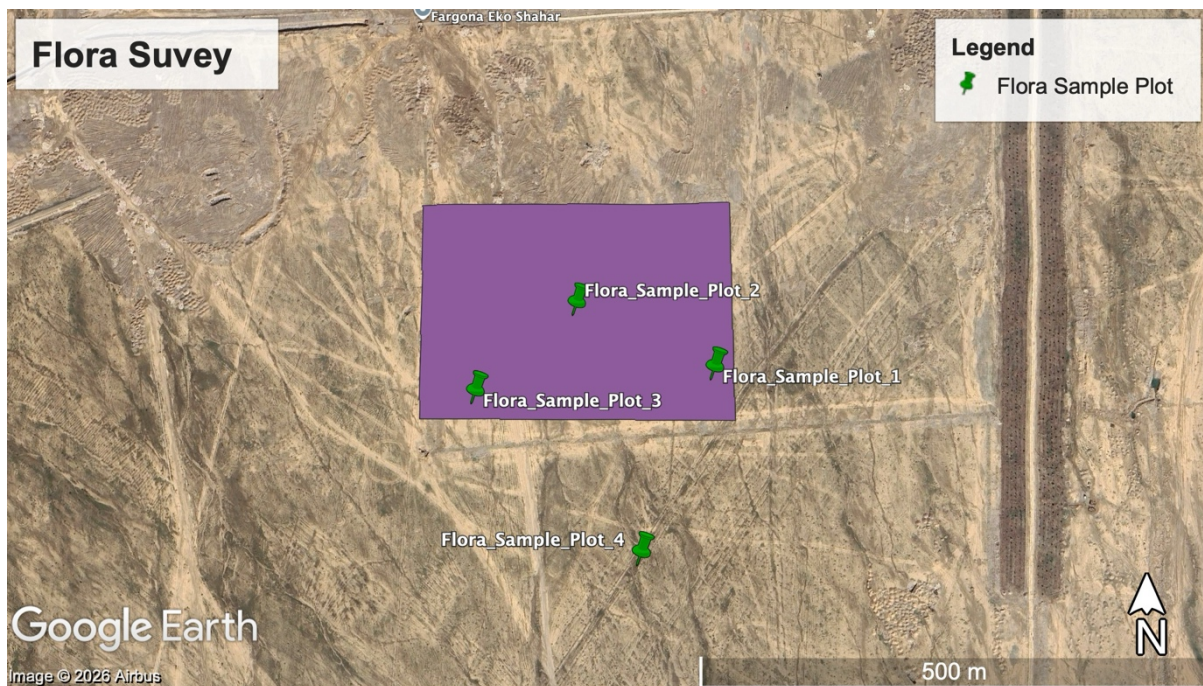
**Figure 5: Flora Sampling Points**

Three sample plots are located within the project area and one outside it. The coordinates of the sample plots are given below in Table 2 and the map in Figure 5.

| <b>Sample Plot</b> | <b>Coordinates</b> | | <b>Notes</b> |
|---|---|---|---|
| <b>SP3</b> | 40°21'50.80"N | 71°43'45.91"E | Within the project site |
| <b>SP4</b> | 40°21'45.55"N | 71°43'53.08"E | Outside of the project site |

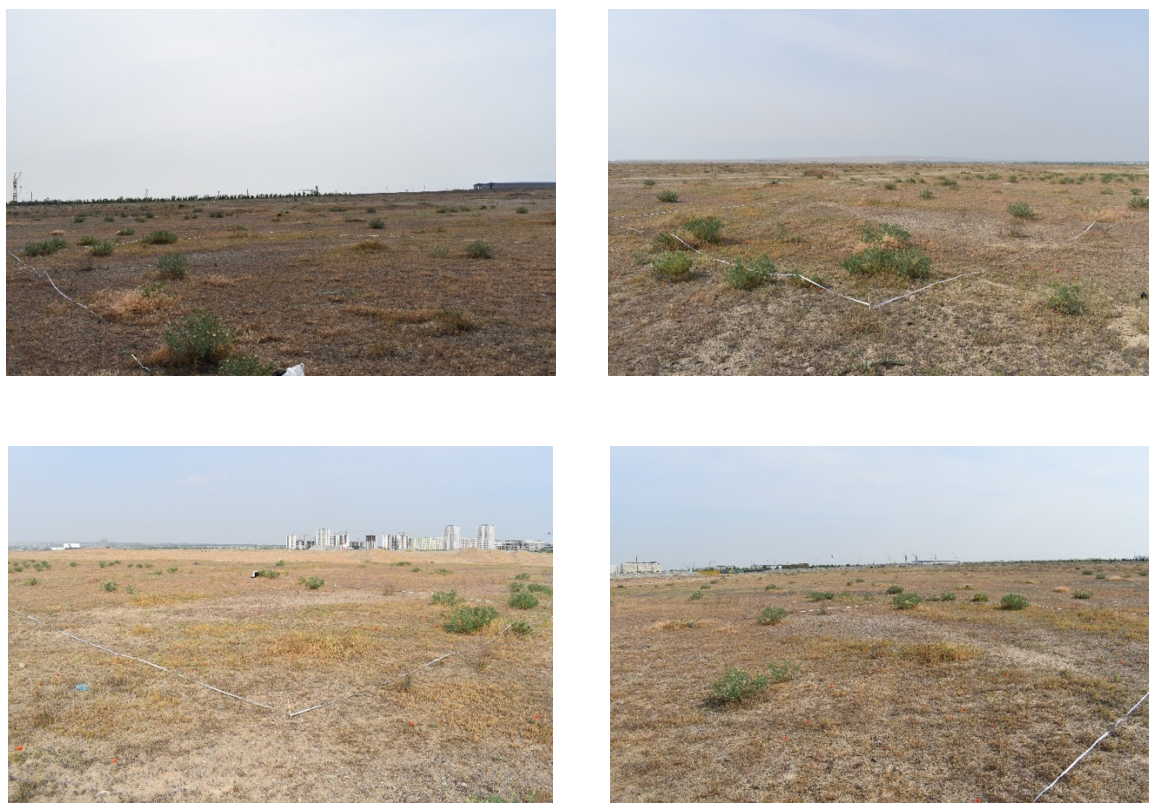
**Figure 7: Sample Plot 1**

Sample plot 1 (SP1) is located in the south-eastern part of the Project site. Coordinates: 40°21'51.59"N 71°43'56.32"E. The area represents a wasteland covered with harmel-ephemeral vegetation (Figure 7).

Vegetation cover is 35-40%, bare ground is 60-65%. 24 plant species were recorded (Table 5). Dominant species are native weedy species *Peganum harmala*, *Hordeum murinum* subsp. *leporinum*, *Bromus tectorum*, *Eremopyrum bonaepartis* and *Festuca orientalis* (*Lolium subulatum*). Alien plants were not recorded. Threatened species listed in the Red Data Book of Uzbekistan or IUCN Red List, or restricted-range endemic species are absent. Anthropogenic disturbance: high (former military training ground, spontaneous garbage dumps). Taking into account sparse vegetation cover, poor species diversity, domination of weedy plants and ephemers, absence of the species of conservation concern, and strong anthropogenic disturbance, this habitat can be considered as a Modified Habitat in accordance with IFC PS6 and the Habitat condition assessment scale presented in Table 3.

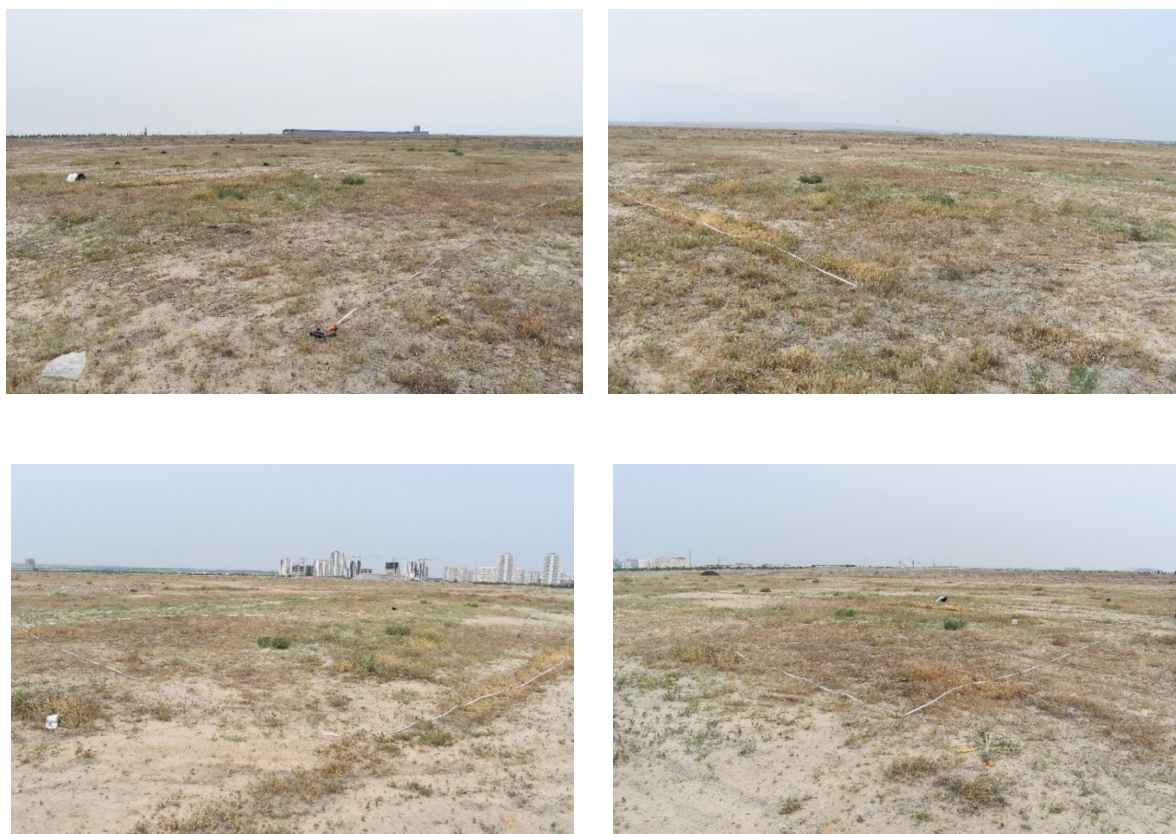
Figure 9: Sample Plot 3

Sample plot 3 (SP3) is located in the southwestern part of the Project site, coordinates 40°21'50.80"N 71°43'45.91"E. The vegetation is harmel-ephemeral community generally similar to SP1, but the canopy cover is relatively sparse (25–30%), and bare ground is 70–75% (Figure 9).

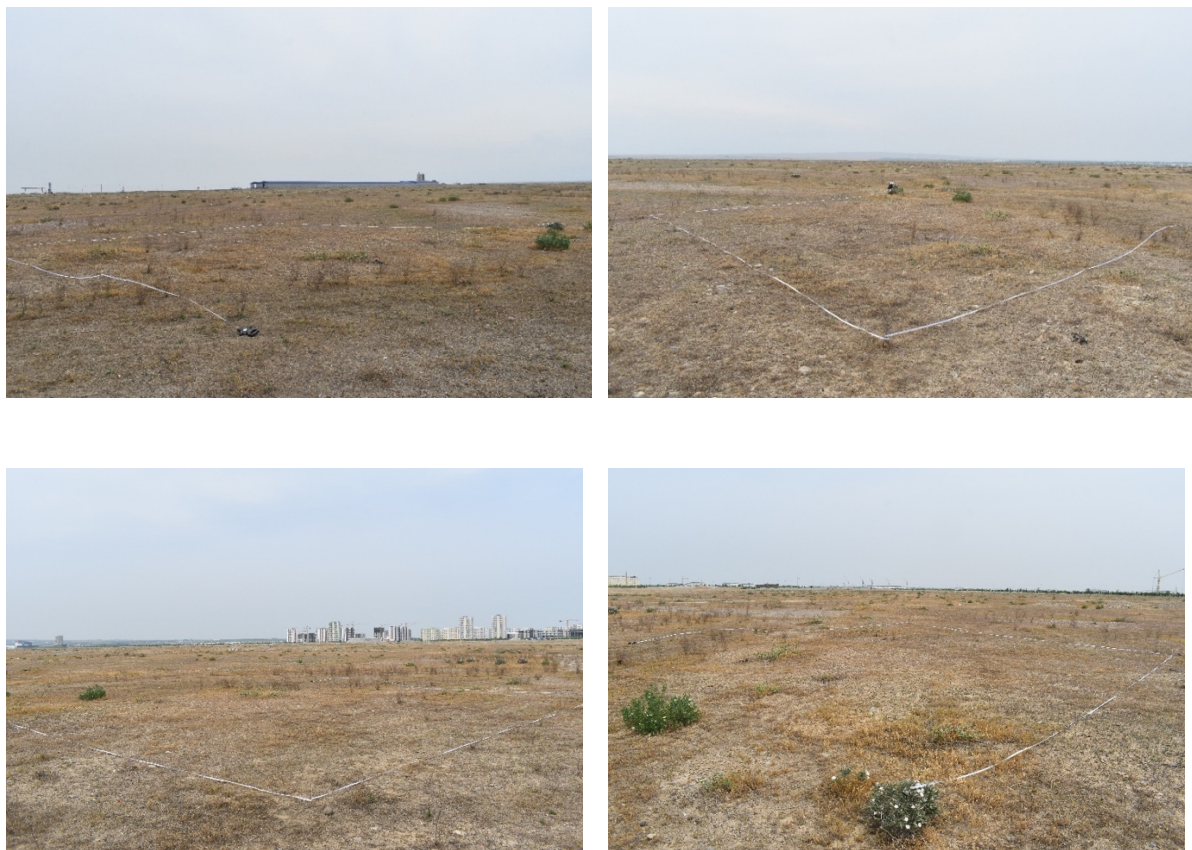
**Figure 10: Sample Plot 4**

Sample plot 4 (SP4) is located outside the Project site, 150 meters from the site's southern boundary (40°21'45.55"N 71°43'53.08"E). In general, the habitat and vegetation is similar with those observed on SP1 and SP3 (Figure 10).

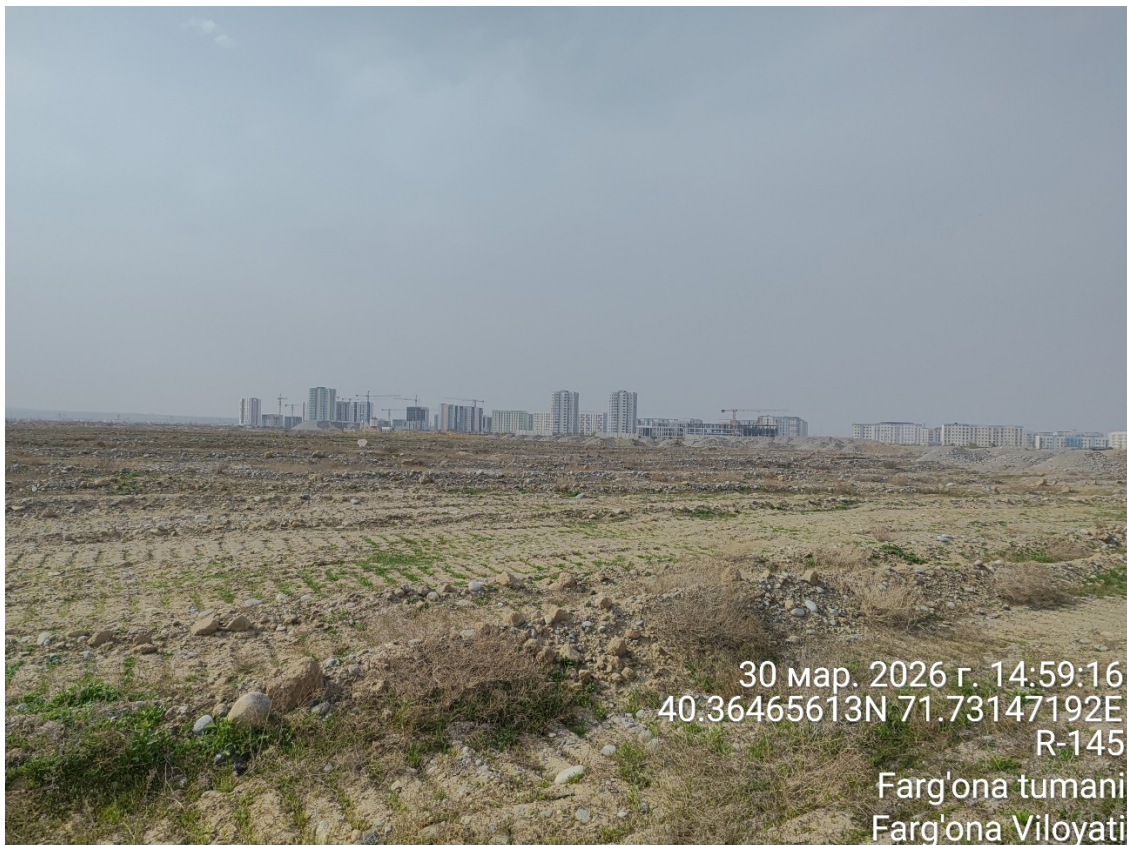
**Figure 2: Construction Near the Project Site**

The area shows widespread signs of human impact. At present, active construction works are being carried out on the plots adjacent to the project area. Construction activities have not yet commenced within the project site; however, the area is actively used for the movement of heavy machinery, as well as for the storage of construction materials and excavated soil from the neighboring developments (Figure 2).
