# Fergana Eco City Regional Hospital – Uzbekistan

## Appendices – Volume 4

### Vision Invest

## Appendix A   Project Layouts

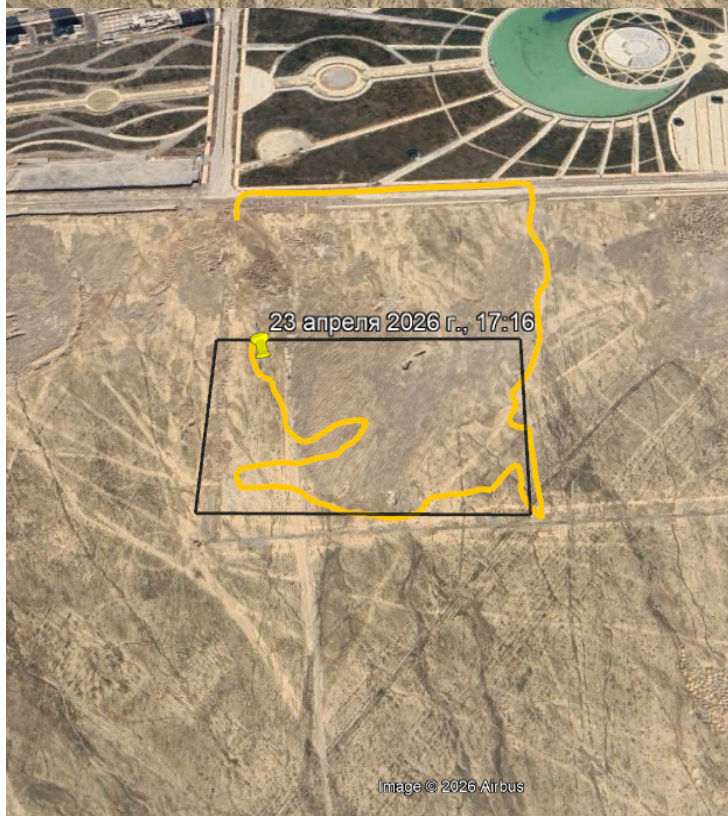
The transect was surveyed on April 23, 2026, in the afternoon from 3:20 p.m. to 5:16 p.m.

The total length of the transect was 1.5 km.

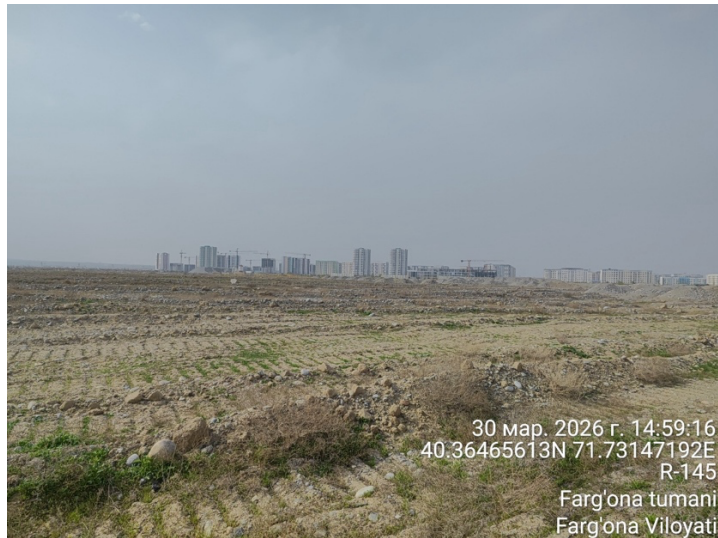
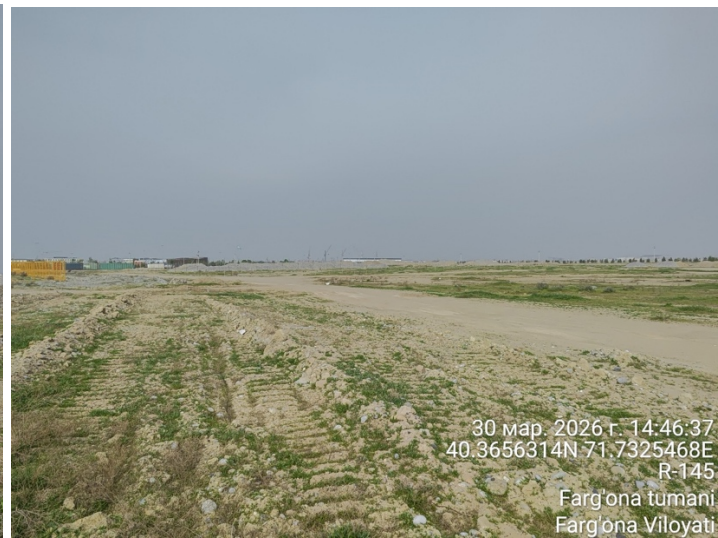
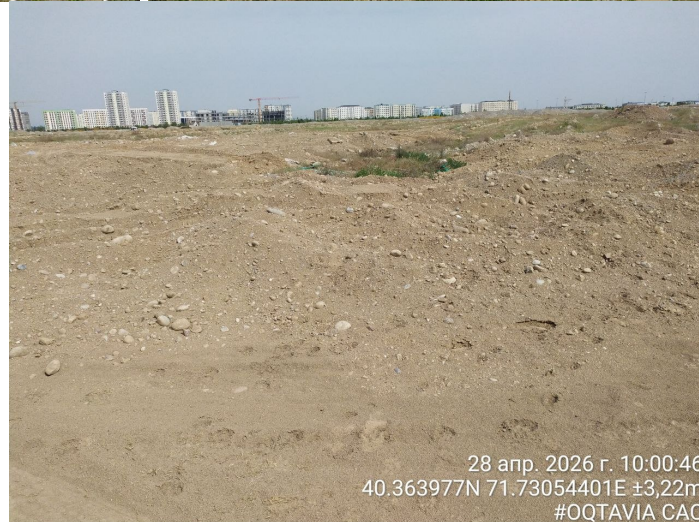
**Figure 2: Construction Near the Project Site**

The area shows widespread signs of human impact. At present, active construction works are being carried out on the plots adjacent to the project area. Construction activities have not yet commenced within the project site; however, the area is actively used for the movement of heavy machinery, as well as for the storage of construction materials and excavated soil from the neighboring developments (Figure 2).

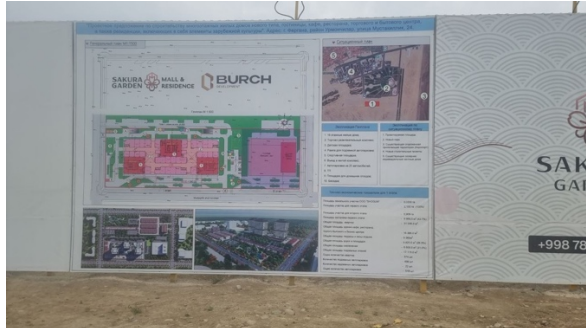
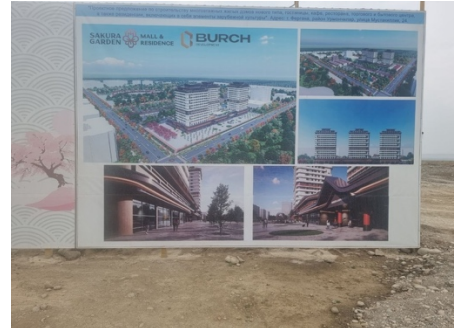
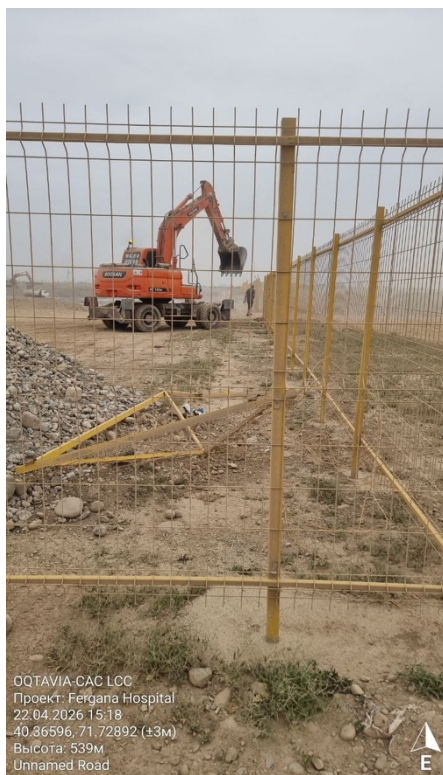
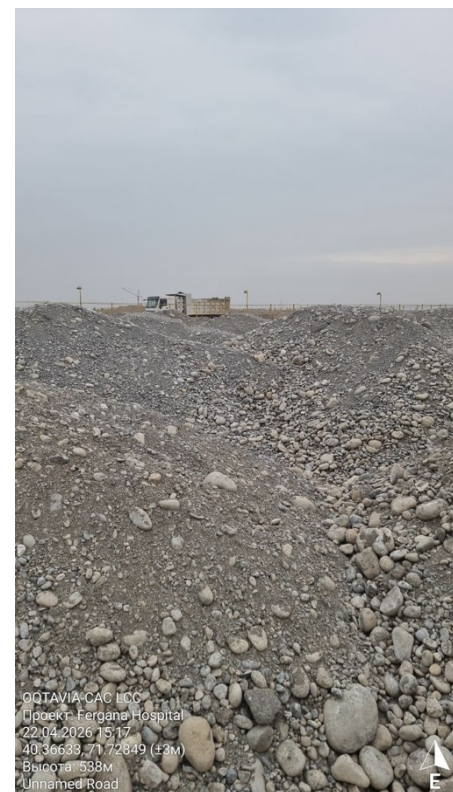
**Figure 3: Construction of the “Sakura Garden Mall & Residence” residential complex, Burch Development**

Additionally, construction work for the “Sakura Garden Mall & Residence” residential complex by Burch Development has begun north of the proposed project site. These works include excavating soil for the foundation of 16-story residential buildings and storing the excavated soil (Figure 3).

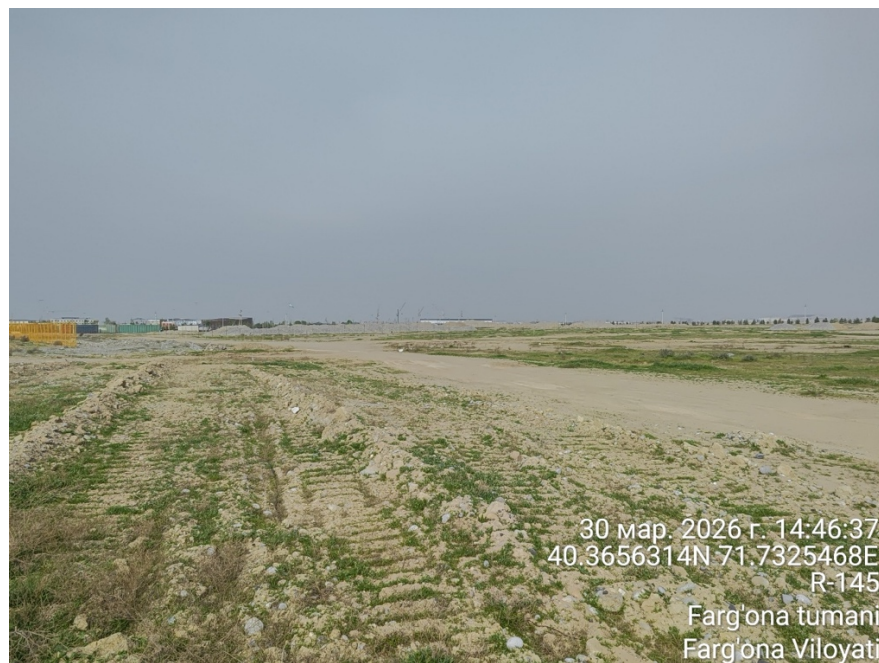
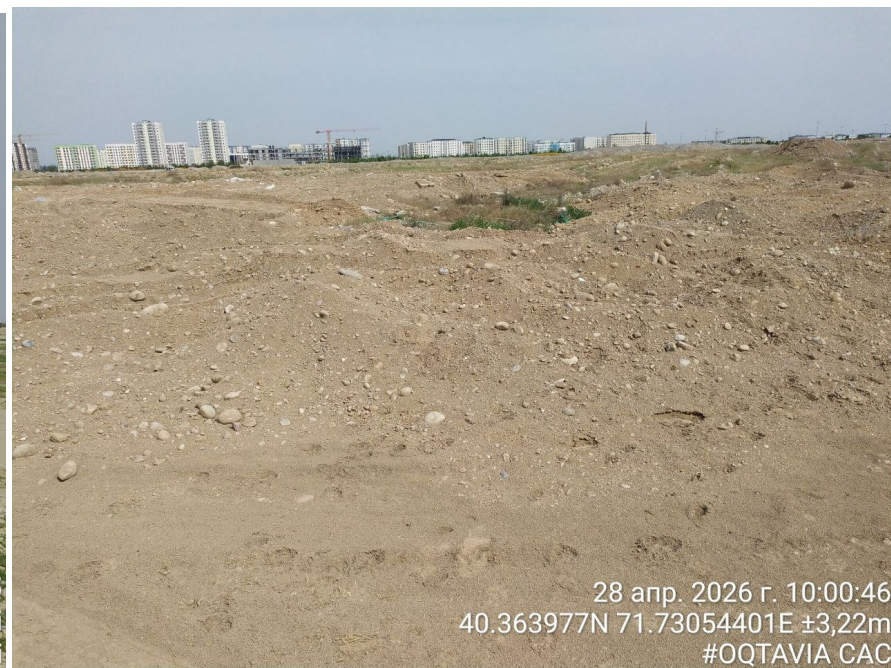
**Figure 2: Construction Near the Project Site**

The area shows widespread signs of human impact. At present, active construction works are being carried out on the plots adjacent to the project area. Construction activities have not yet commenced within the project site; however, the area is actively used for the movement of heavy machinery, as well as for the storage of construction materials and excavated soil from the neighboring developments (Figure 2).

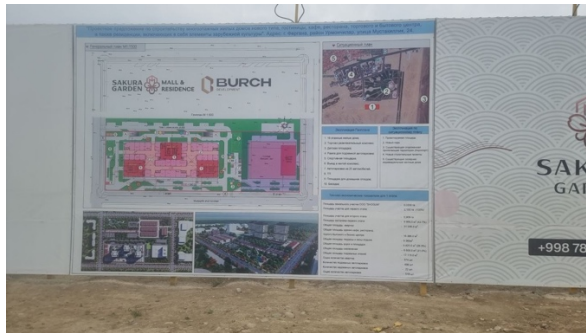
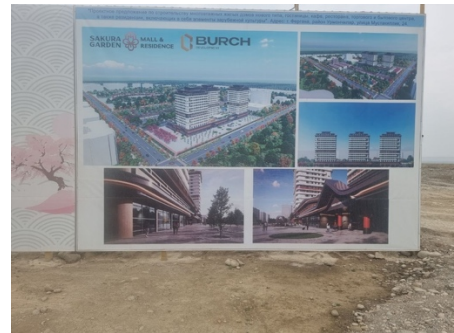
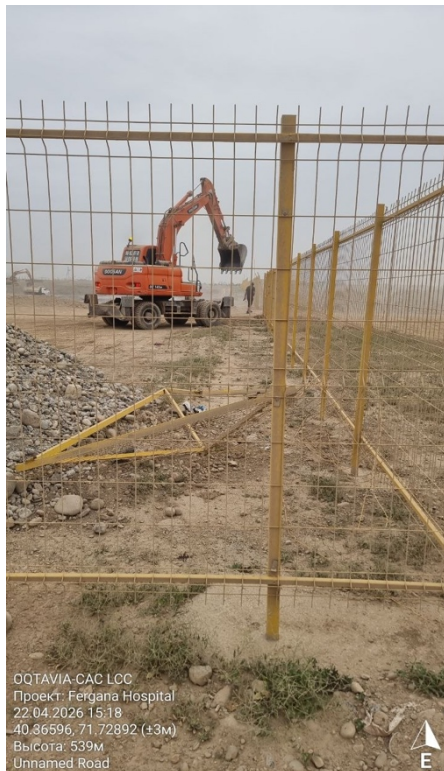
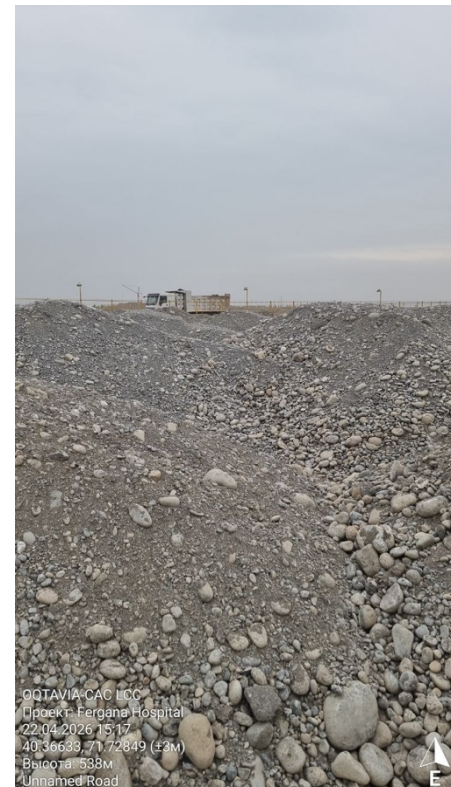
**Figure 3: Construction of the “Sakura Garden Mall & Residence” residential complex, Burch Development**

Additionally, construction work for the “Sakura Garden Mall & Residence” residential complex by Burch Development has begun north of the proposed project site. These works include excavating soil for the foundation of 16-story residential buildings and storing the excavated soil (Figure 3).

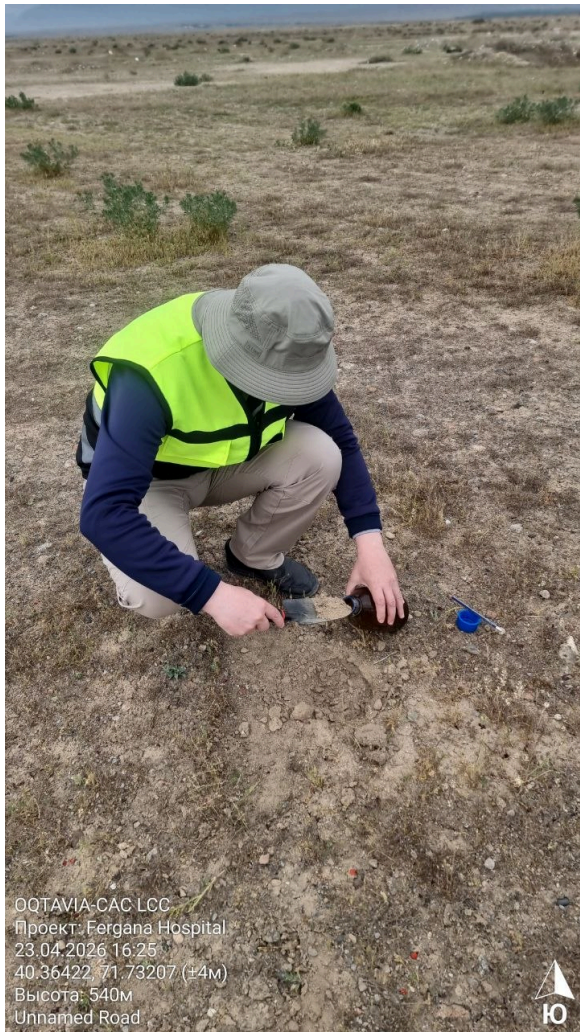
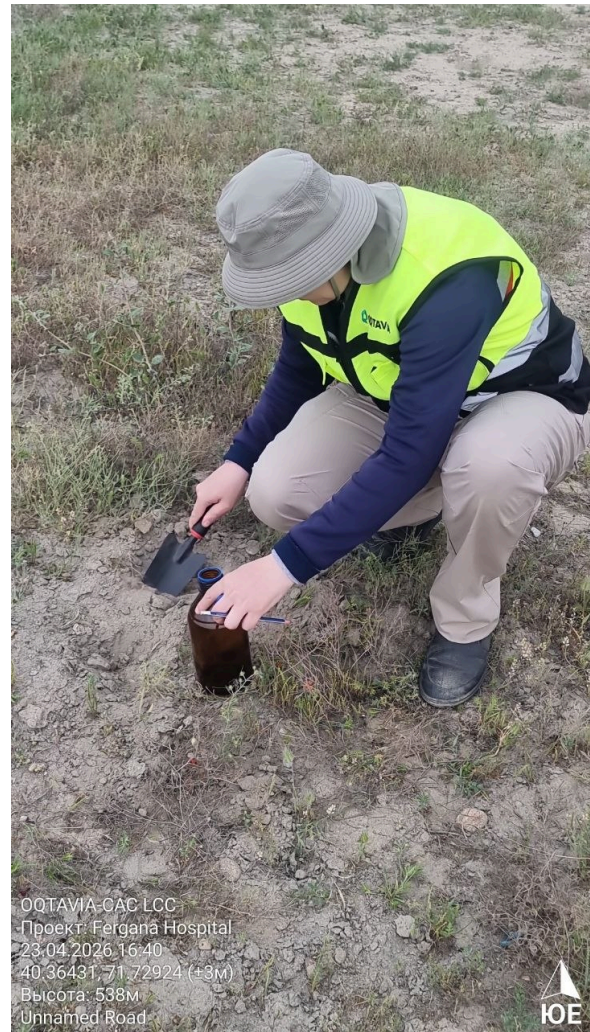
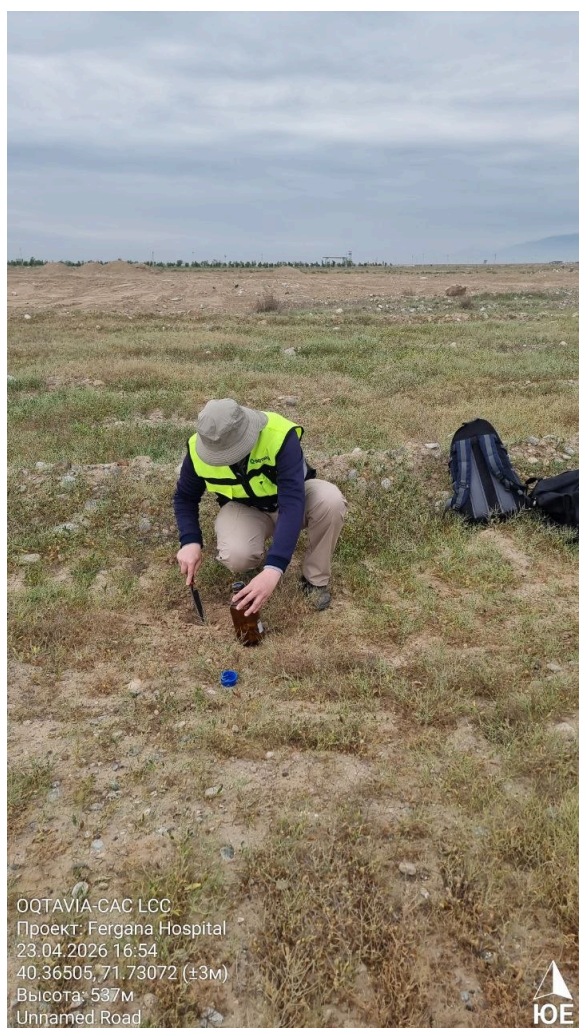
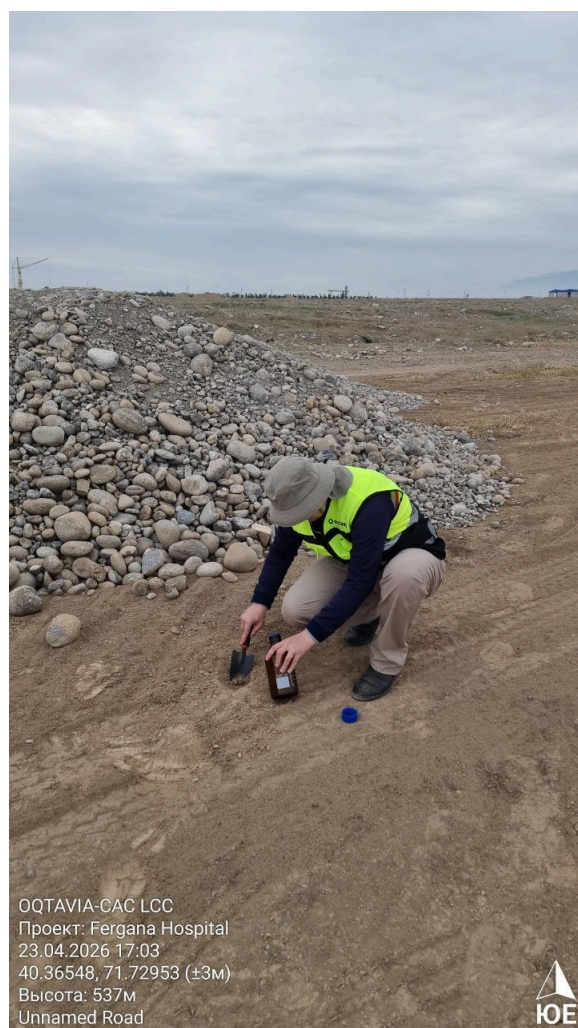
**Figure 5: Soil Sampling**

Soil samples were taken on 23 April 2026 at four sample plots within the project area (Table 1 and Figure 4). All samples were collected using appropriate tools, stored in clean containers, and labeled (Figure 5).

The collected soil samples were transported under controlled conditions to an accredited laboratory, the Agency of the Hydrometeorological Service under the National Committee on Ecology and Climate Change of the Republic of Uzbekistan.

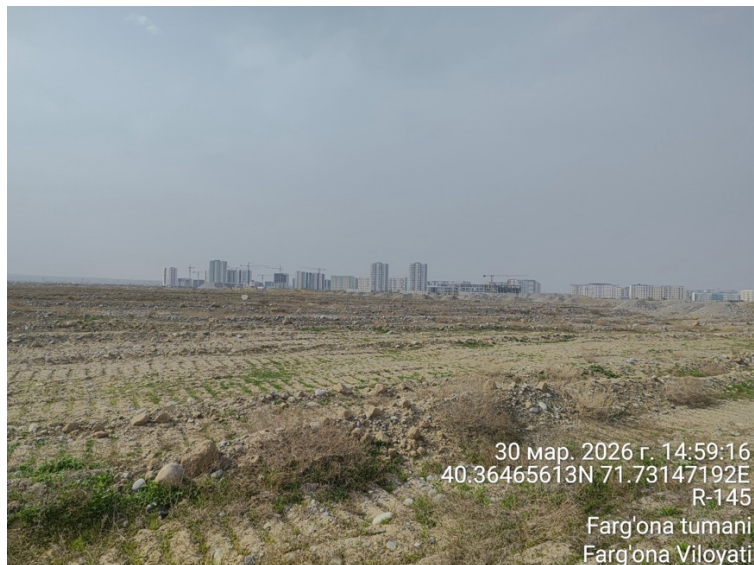
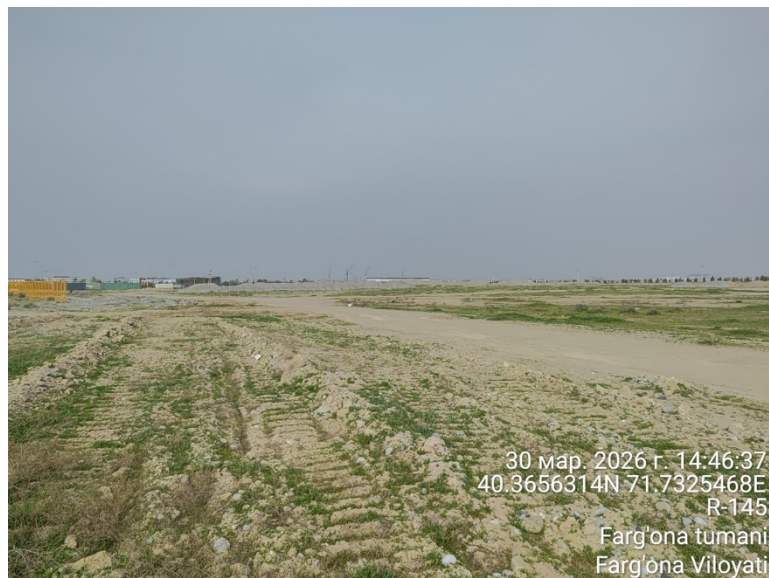
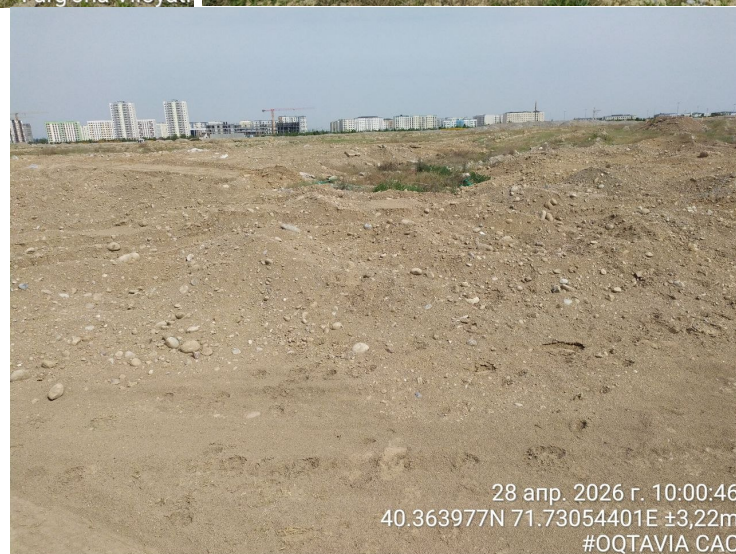
**Figure 2: Construction Near the Project Site**

The area shows widespread signs of human impact. At present, active construction works are being carried out on the plots adjacent to the project area. Construction activities have not yet commenced within the project site; however, the area is actively used for the movement of heavy machinery, as well as for the storage of construction materials and excavated soil from the neighboring developments (Figure 2).

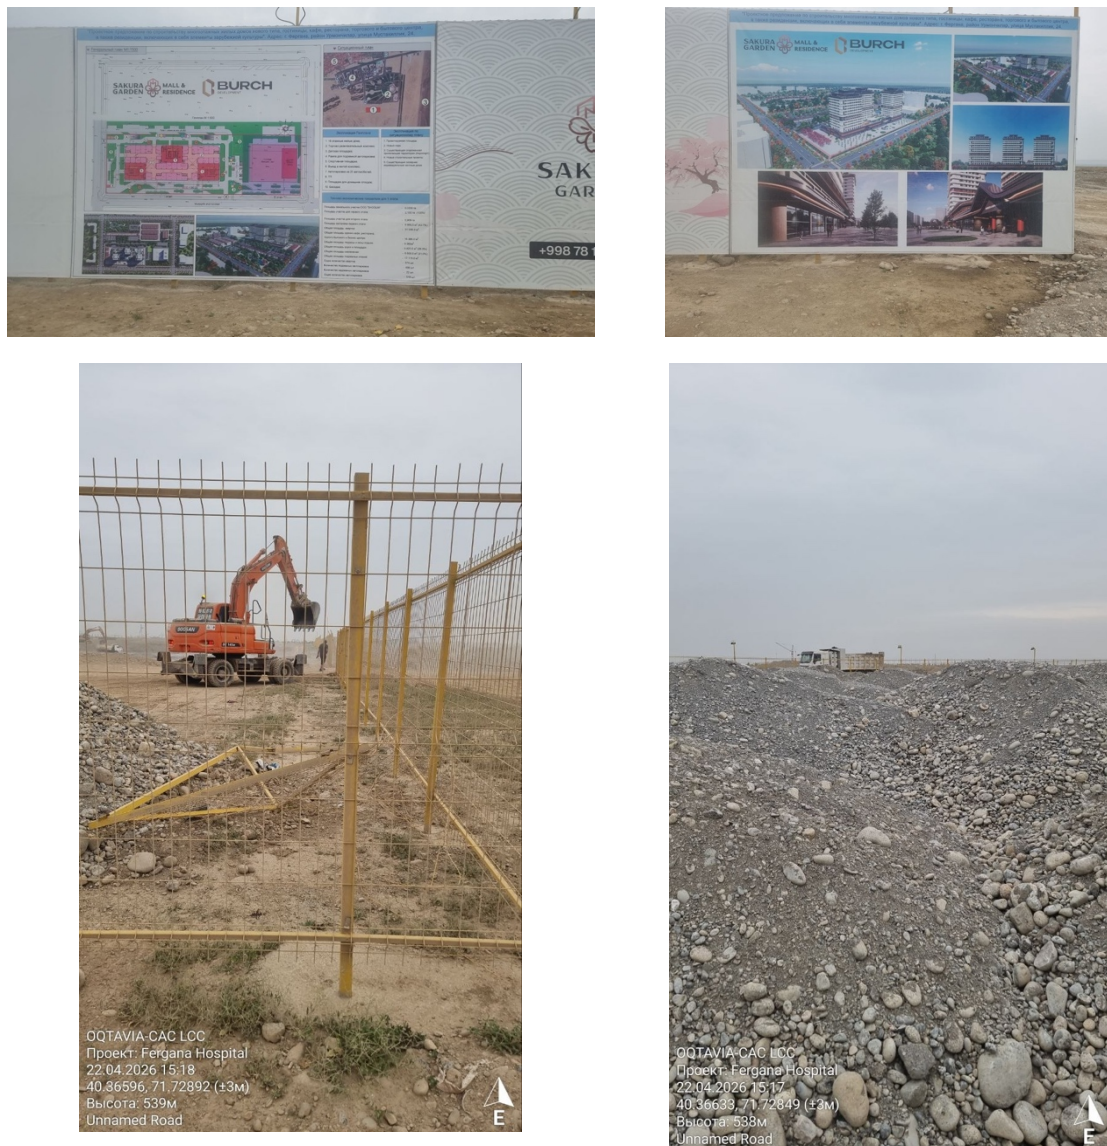
**Figure 3: Construction of the “Sakura Garden Mall & Residence” residential complex, Burch Development**

Additionally, construction work for the “Sakura Garden Mall & Residence” residential complex by Burch Development has begun north of the proposed project site. These works include excavating soil for the foundation of 16-story residential buildings and storing the excavated soil (Figure 3).
